Test Report

μCT Analysis

Internal Report Number: μCT-560-01

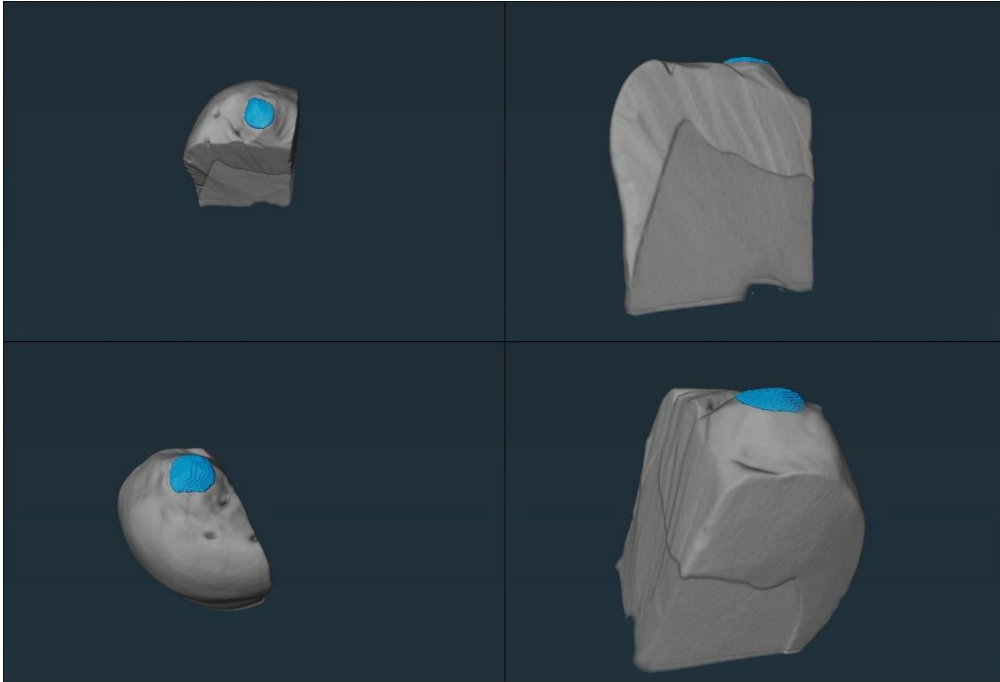
Figure 1: Abrasion (blue) on specimen 1

Specimen	Abrasion volume [mm ³]
1	0,24
2	26,63
3	0,31
4	0,69

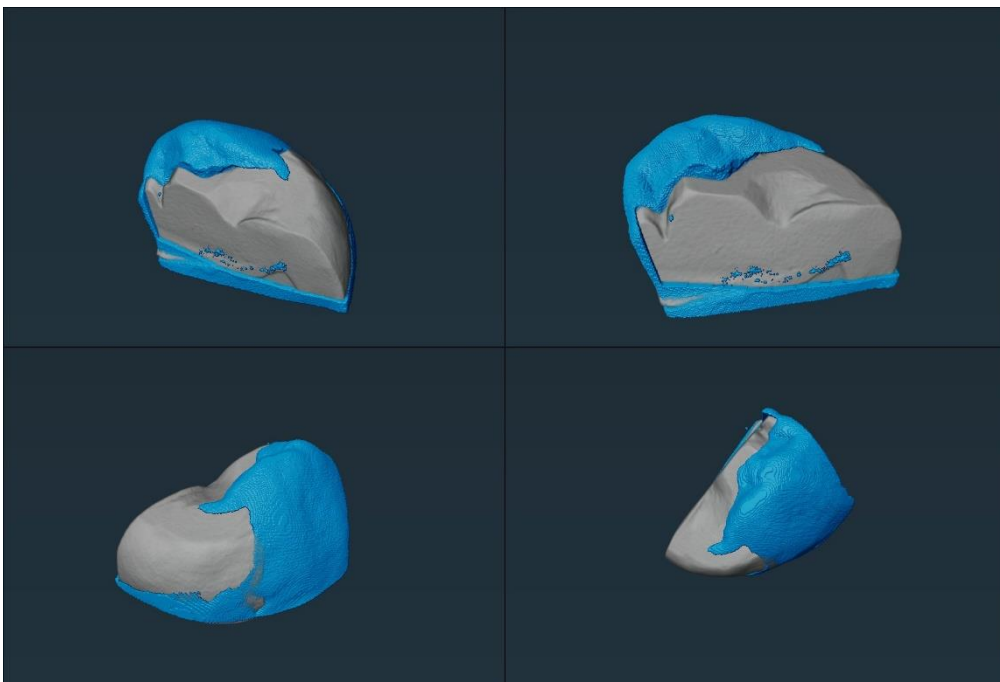
Figure 2: Abrasion (blue) on specimen 2

Specimen 2 was quite fractured and missing some parts as can be seen in Figure 2 that is why the volume is that high.

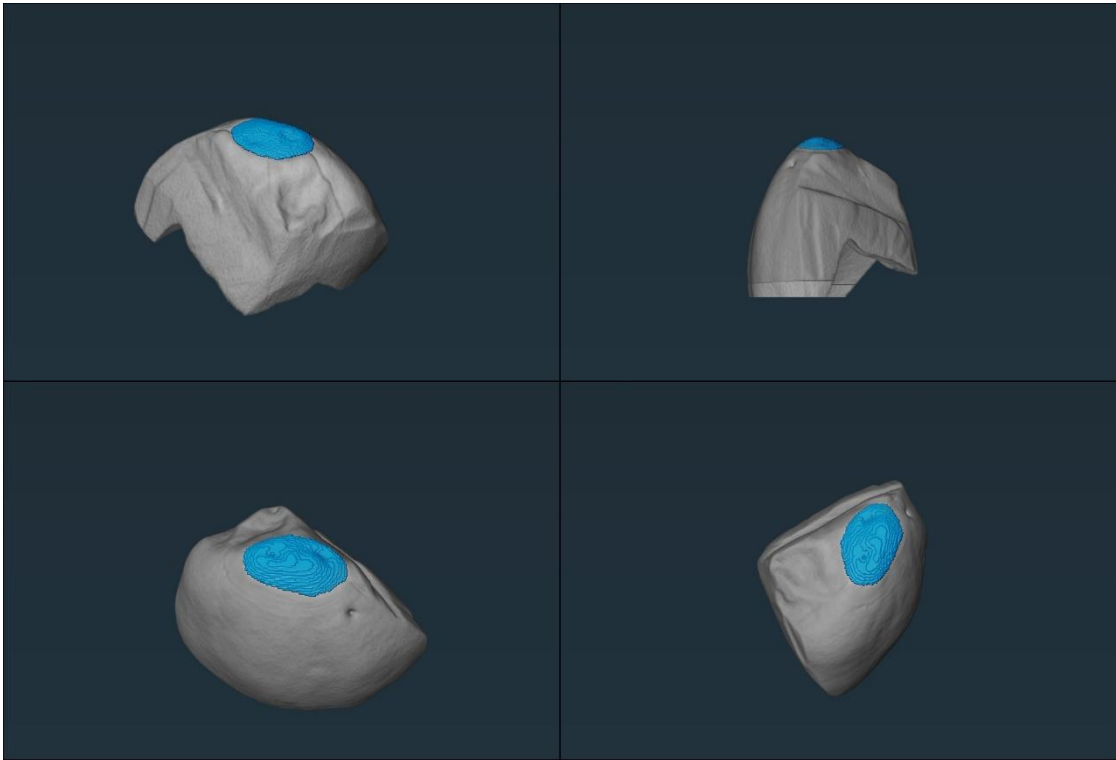
Figure 3: Abrasion (blue) on specimen 3

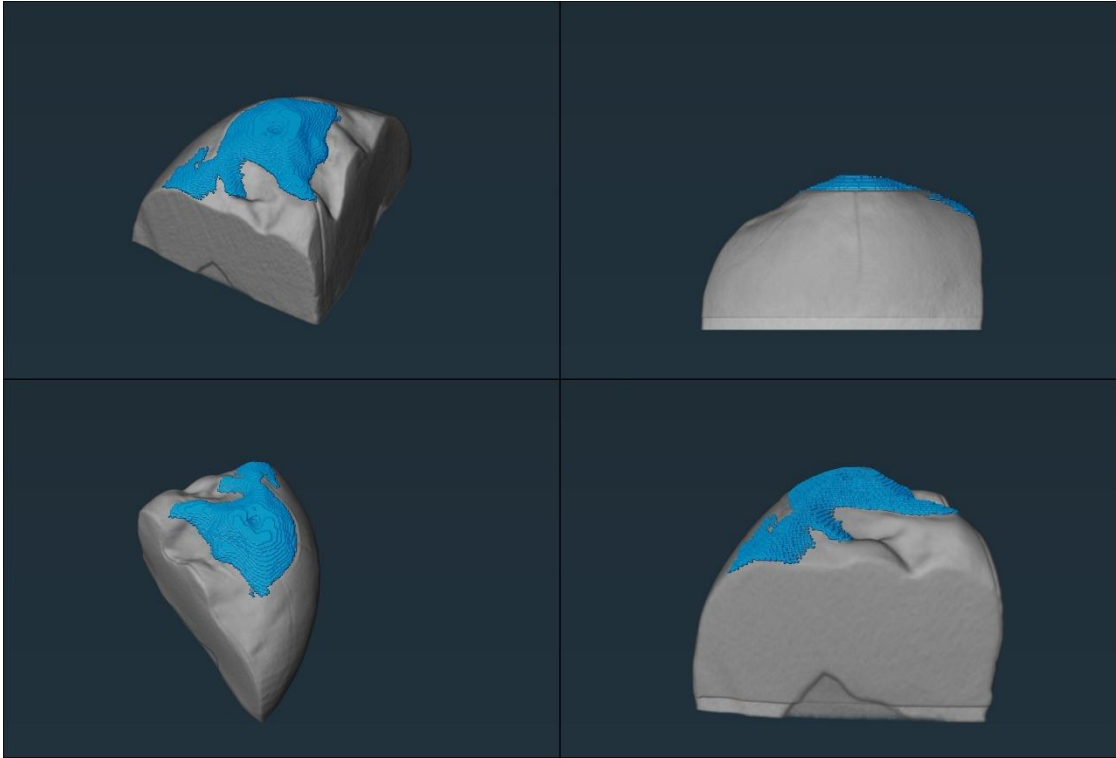
Figure 4: Abrasion (blue) on specimen 4

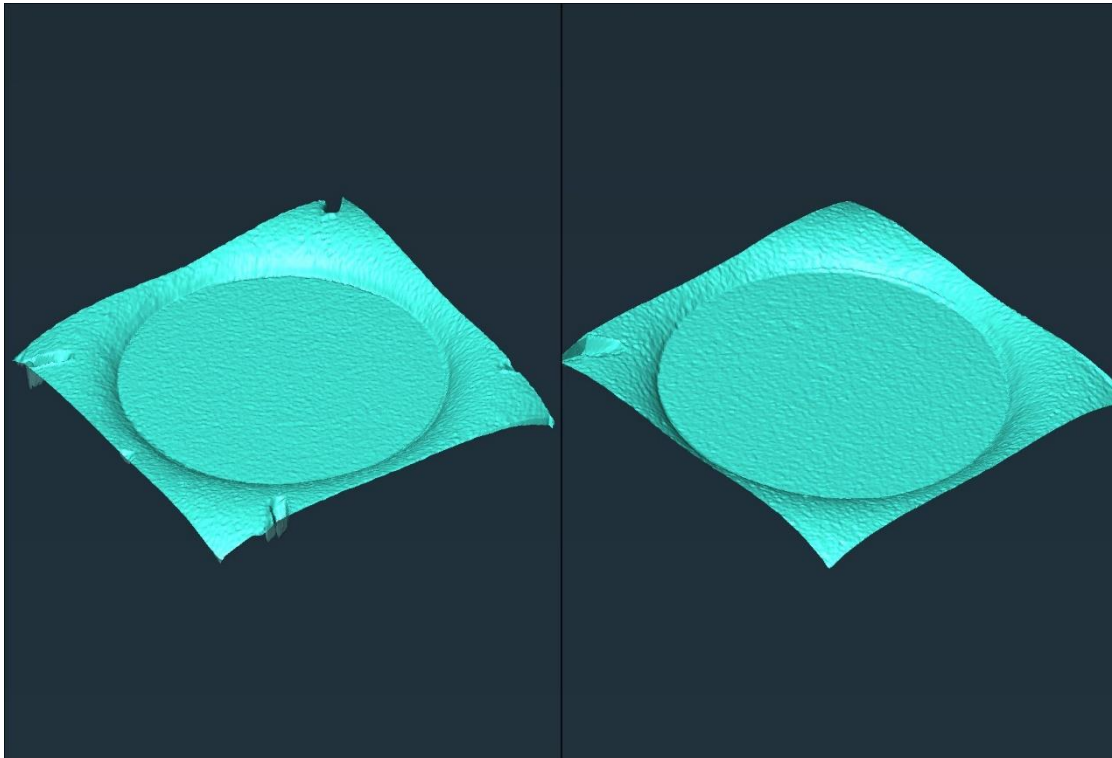
Figure 5: Before and after scan of antagonist A

Following the abrasion volume of the specimen are shown. On the antagonists (specimen A, B, I, K) no abrasion could be measured.

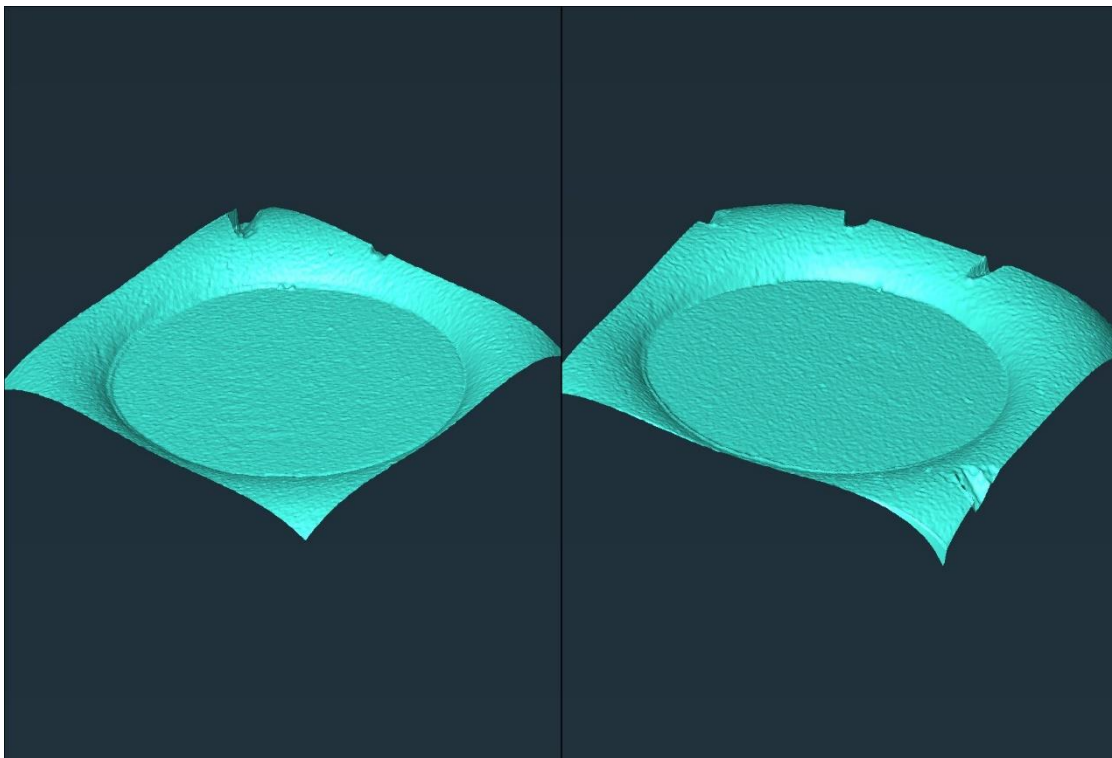
Figure 6: Before and after scan of antagonist B

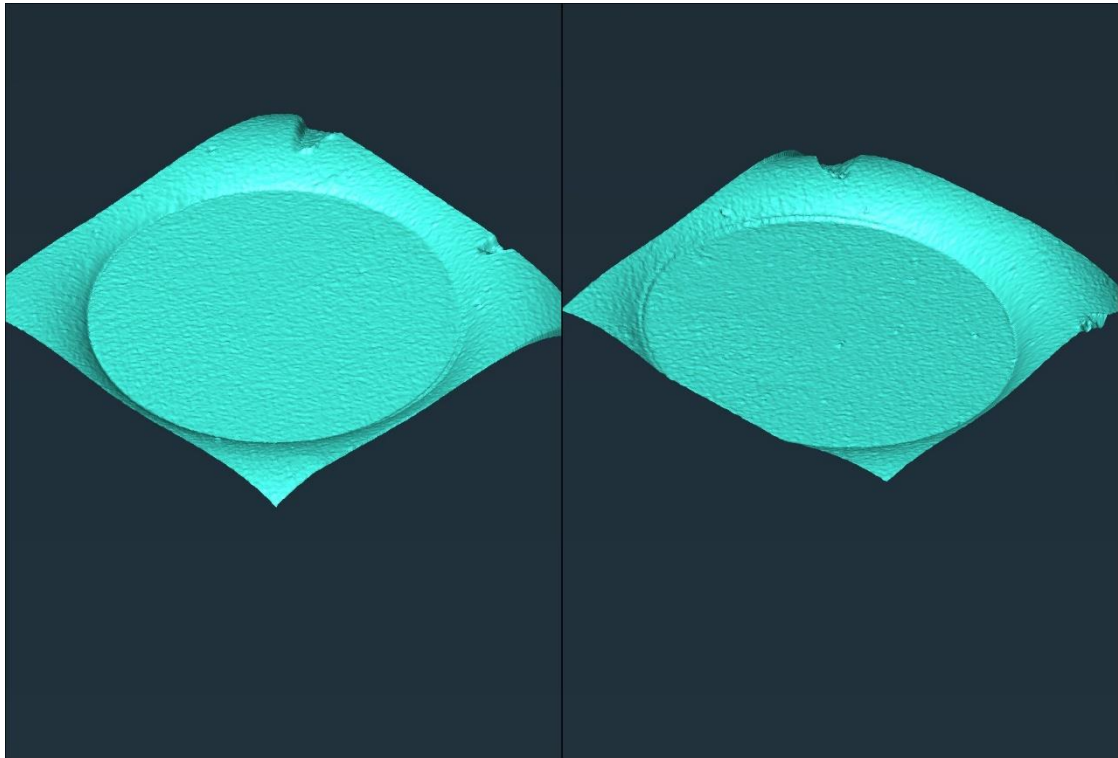
Figure 7: Before and after scan of antagonist I

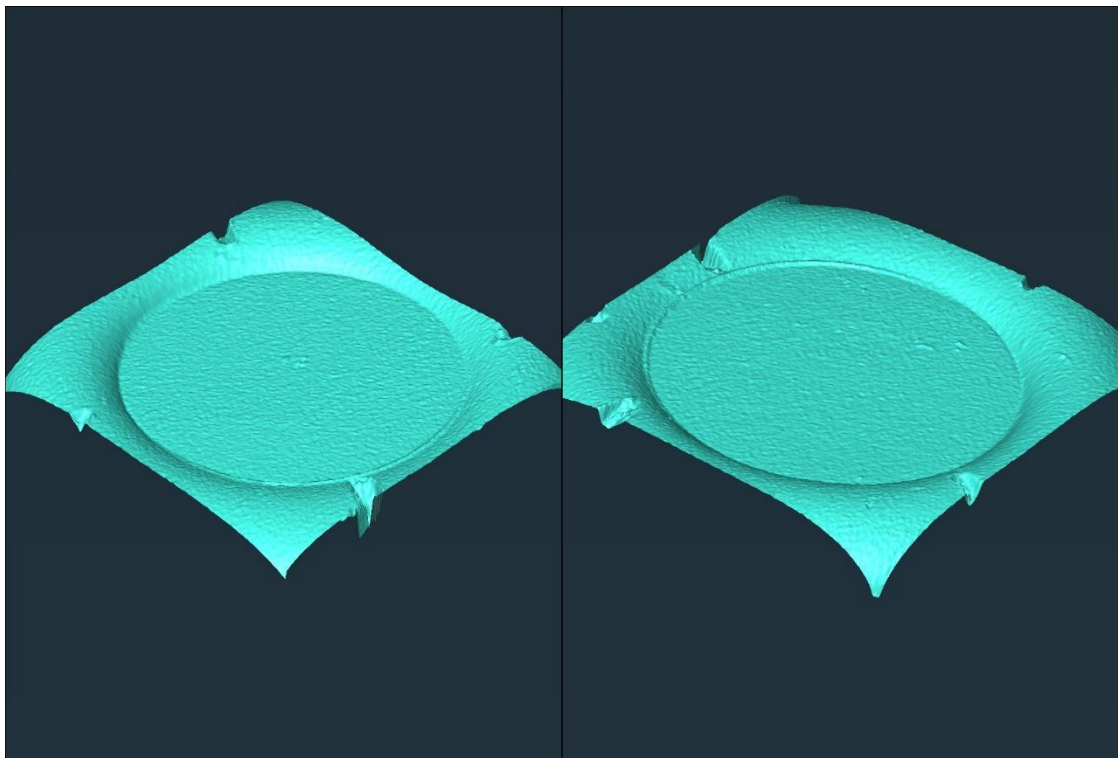
Figure 8: Before and after scan of antagonist K
